**CWA OVERSIGHT INSPECTION REPORT**

## "Rockford Region Agricultural Field Investigation Report"

**File:** Scheidairy Farms, Inc.  
**County:** Stephenson  
**Date:** May 24, 2011 9:45 AM - 1:25 PM  
**Address:** 1730 W. Buckeye Road  
Freeport, IL 61032

SCHEIDAIRY FARMS – 1730 W Buckeye Rd, Freeport IL – 5/24/2011 Inspection

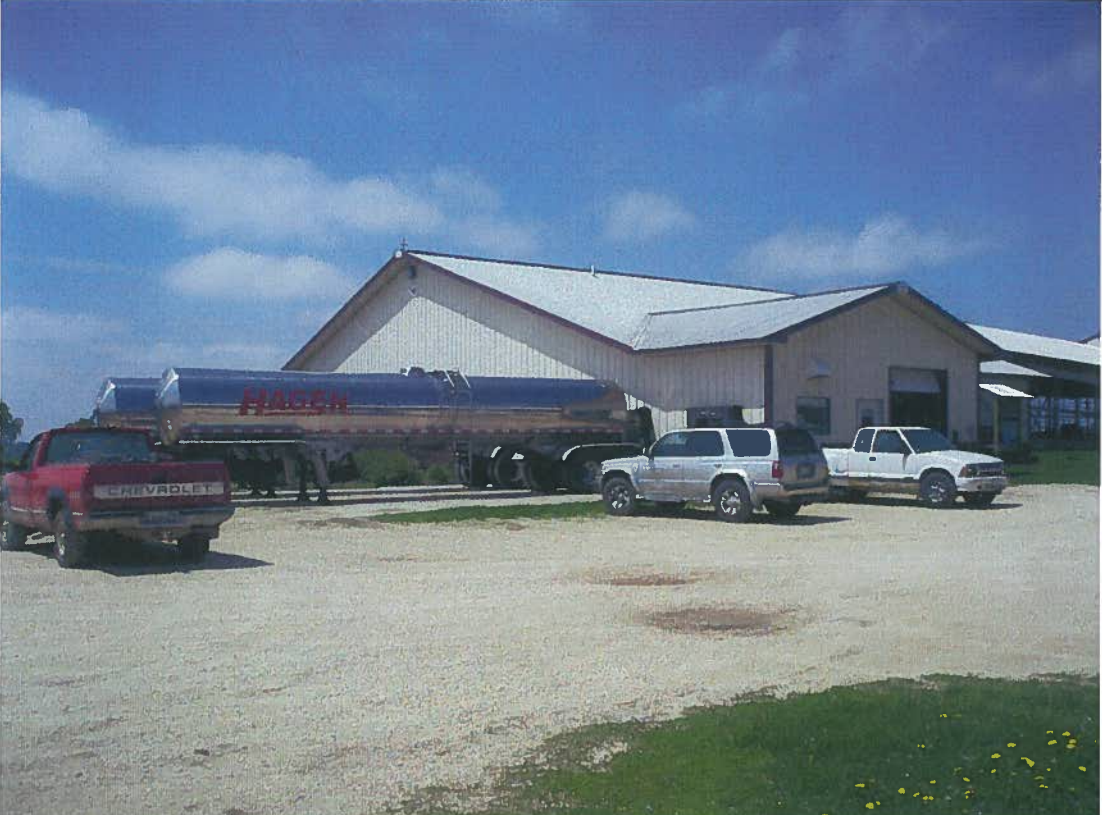
<b>County:</b> Stephenson	
<b>Comments:</b> View of office, milk parlor, and bulk tankers. View is west.	
<b>Photo #:</b> 1	
<b>Photo Title:</b> 052411_ ScheidairyFarms_KWB(4)

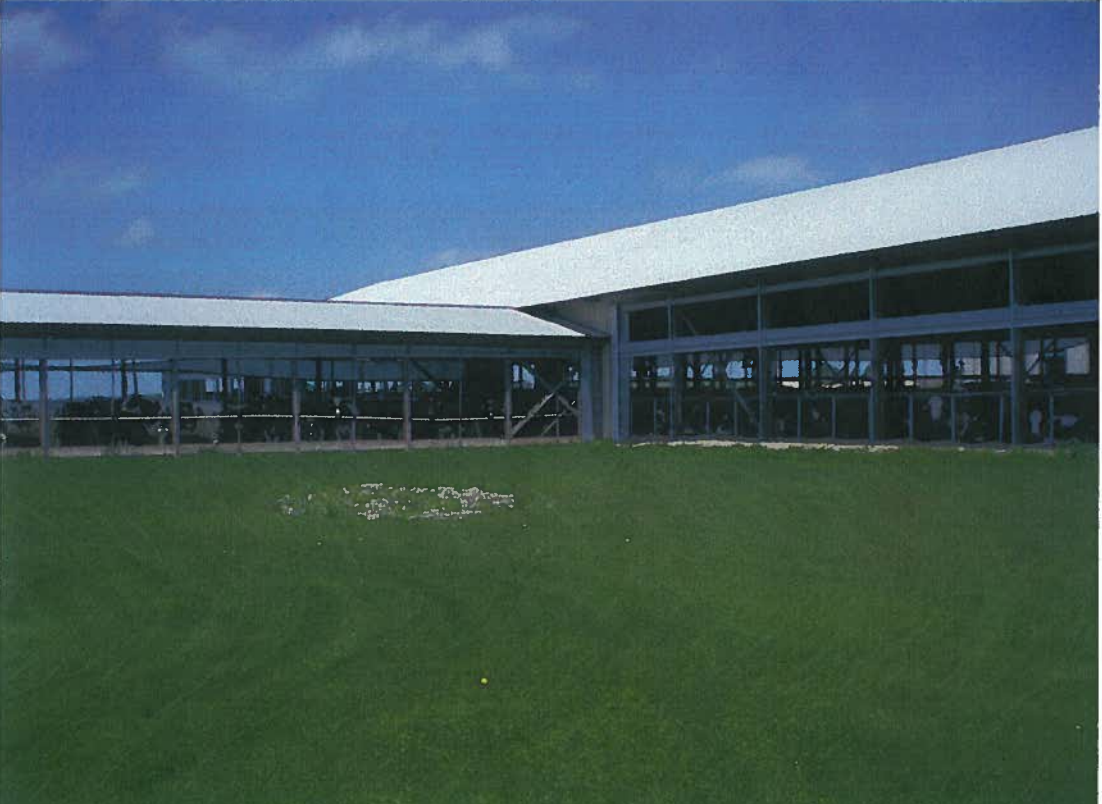
<b>County:</b> Stephenson	
<b>Comments:</b> View of freestall barn. Storm water flows to tile inlet in rip rap at center of photo. View is north.	
<b>Photo#:</b> 2	
<b>Photo Title:</b> 052411_ ScheidairyFarms_KWB(3)

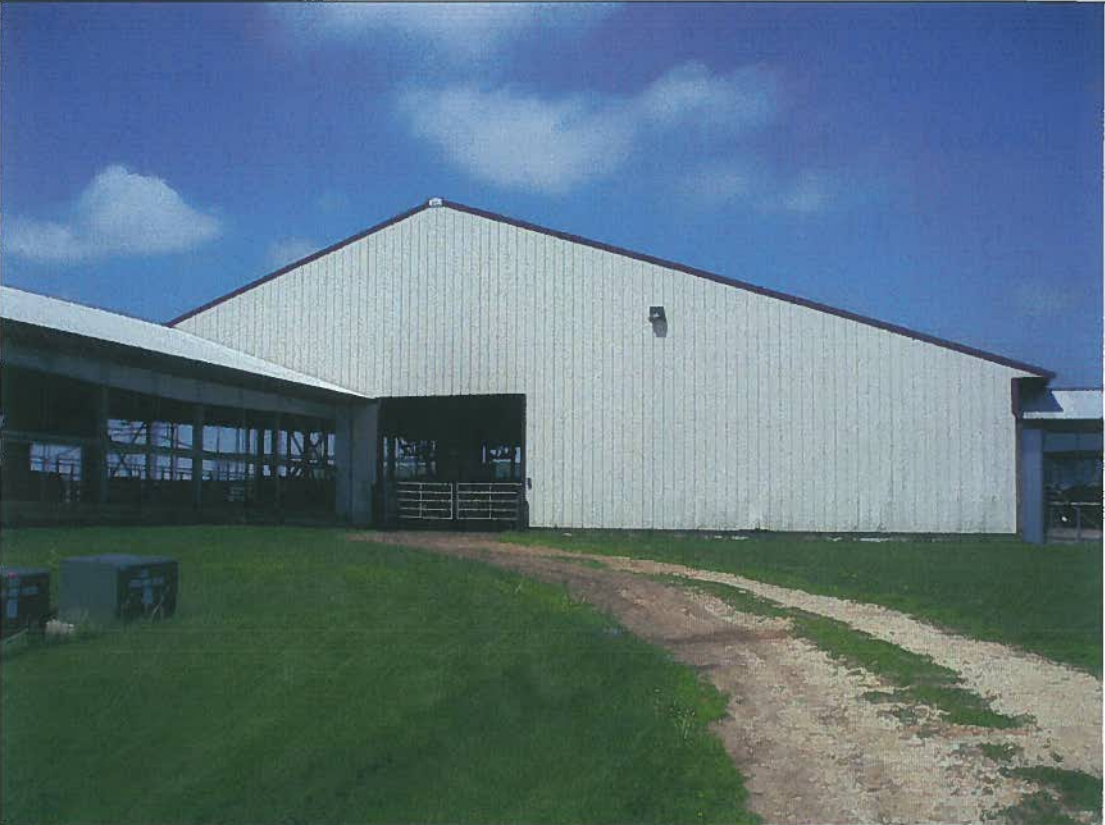
<b>County:</b> Stephenson	
<b>Comments:</b> View of special needs barn. View is northwest.	
<b>Photo #:</b> 3	
<b>Photo Title:</b> 052411_ ScheidairyFarms_KWB(1)

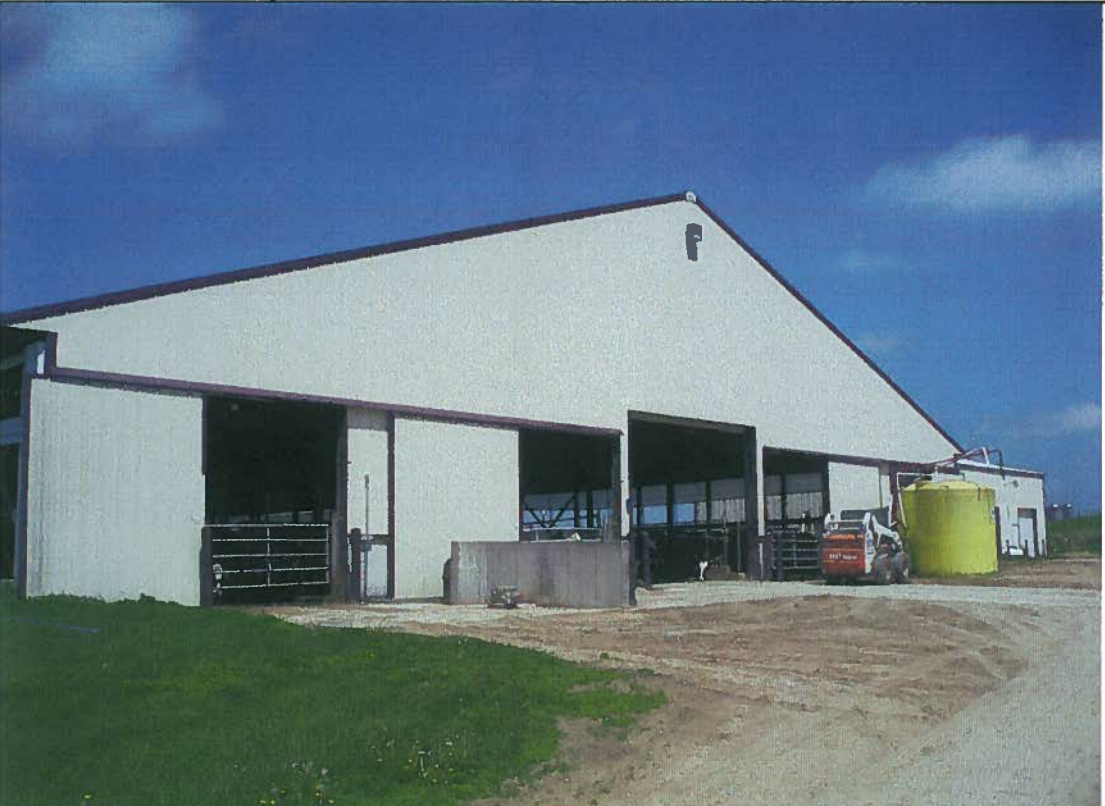
<b>County:</b> Stephenson	
<b>Comments:</b> View of freestall barn. View is northwest.	
<b>Photo #:</b> 4	
<b>Photo Title:</b> 052411_ ScheidairyFarms_KWB(5)

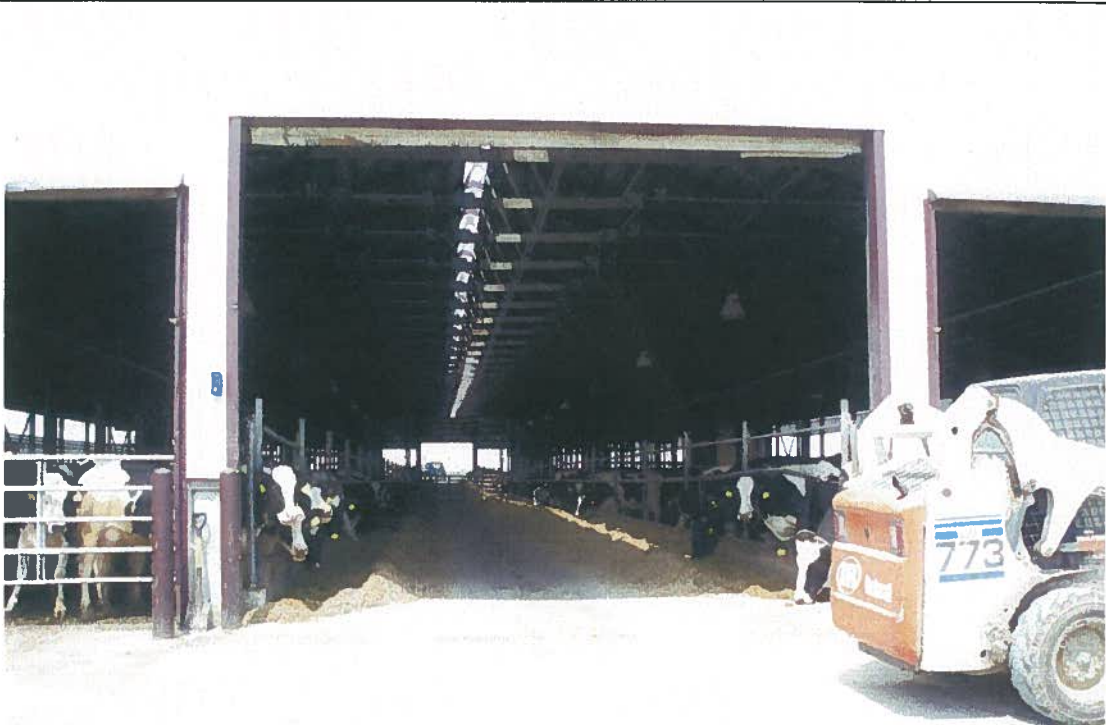
<b>County:</b> Stephenson	
<b>Comments:</b> View of freestall barn showing interior. View is northwest.	
<b>Photo #:</b> 5	
<b>Photo Title:</b> 052411_ScheidairyFarms_KWB(8)

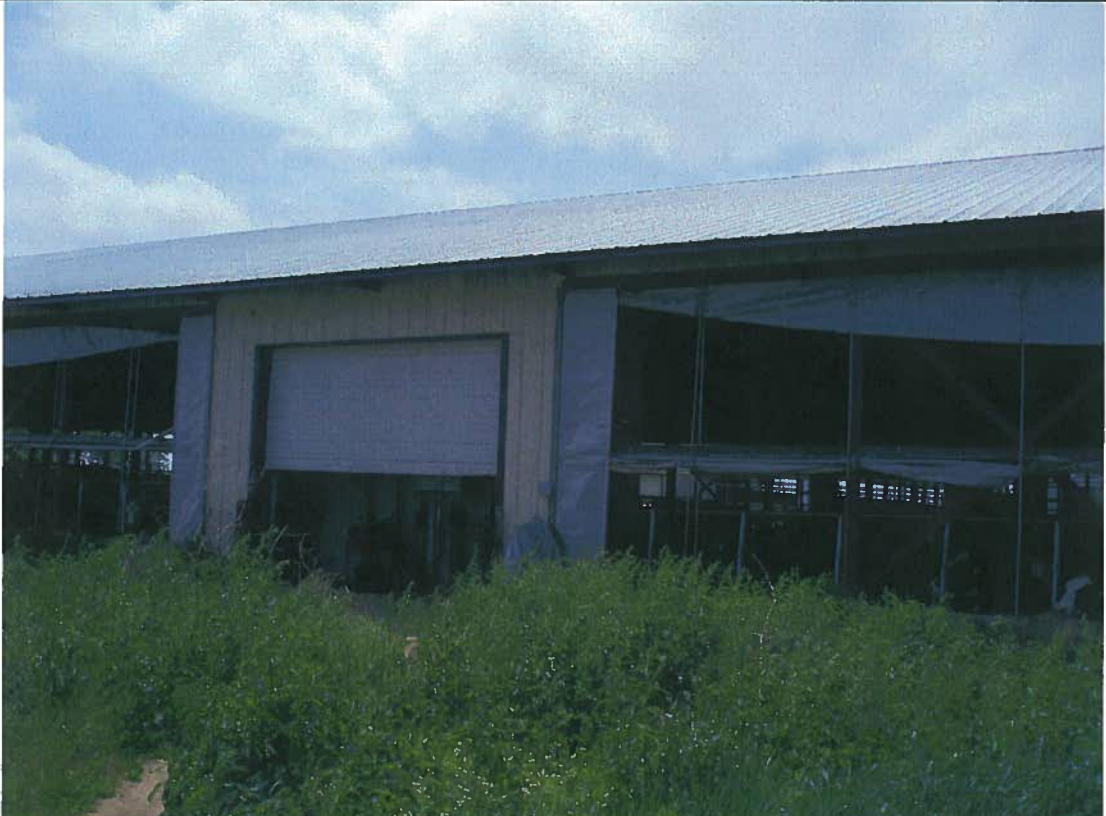
<b>County:</b> Stephenson	
<b>Comments:</b> View of freestall barn showing piston pump in garage that transfers manure to waste handling facilities.	
<b>Photo#:</b> 6	
<b>Photo Title:</b> 052411_ScheidairyFarms_KWB(18)

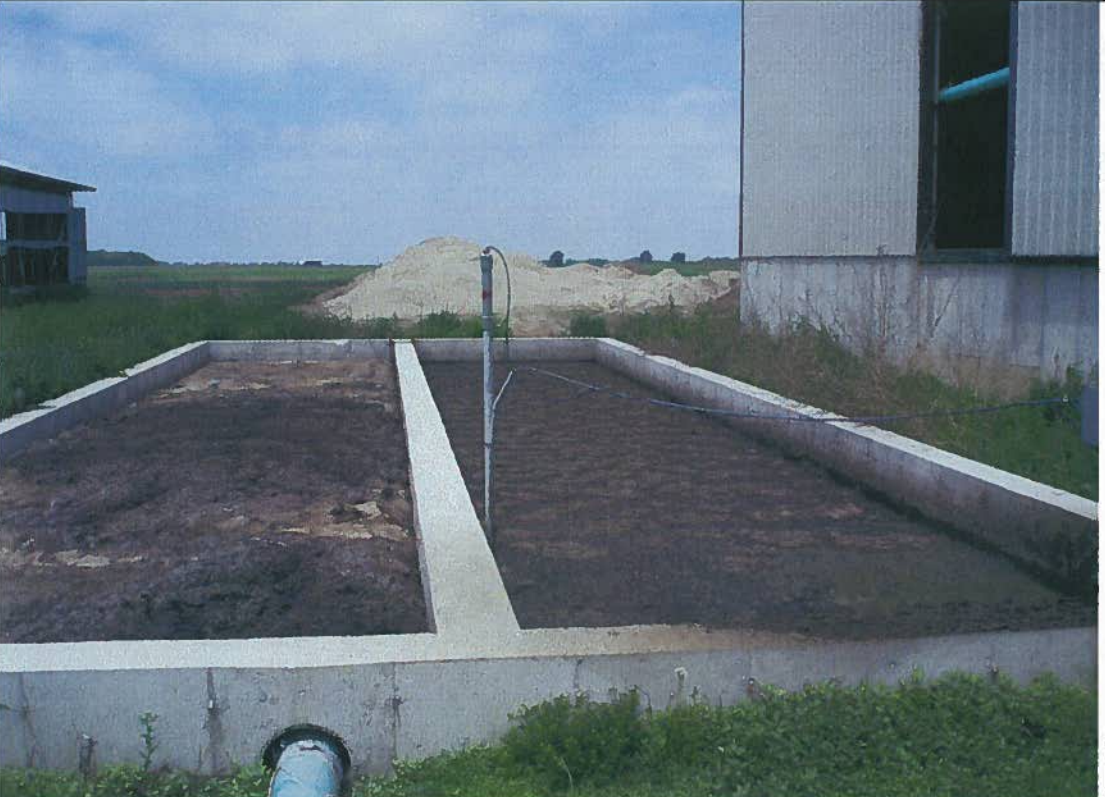
<b>County:</b> Stephenson	
<b>Comments:</b> View of gray water basins. Water flows from milking parlor to basins and is recycled in sand and manure separation. Excess gray water is pumped to the anaerobic digester.	
<b>Photo #:</b> 8	
<b>Photo Title:</b> 052411_ ScheidairyFarms_KWB(19)

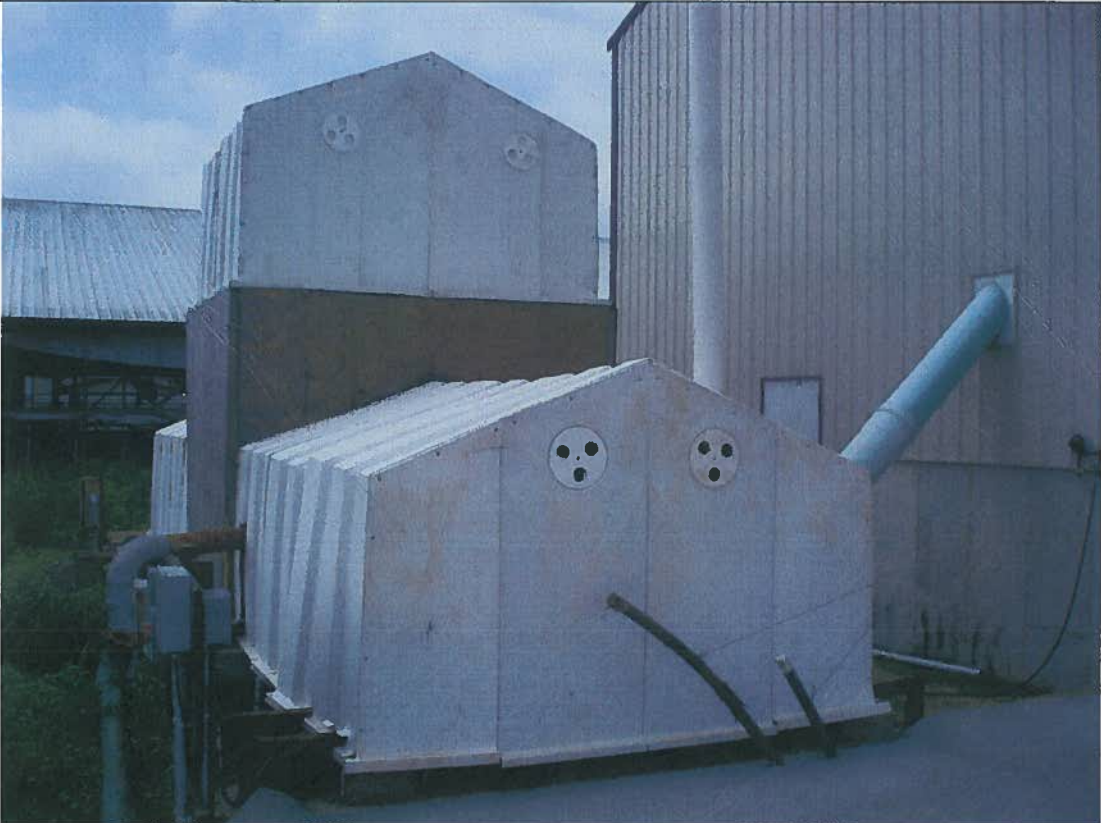
<b>County:</b> Stephenson	
<b>Comments:</b> View of covered pit housing pumps adjacent to sand separator building. Freestall barn is in background. Runoff from recycled sand storage will flow to pit via opening under the front shed. View is southwest.	
<b>Photo #:</b> 9	
<b>Photo Title:</b> 052411_ScheidairyFarms_KWB(23)

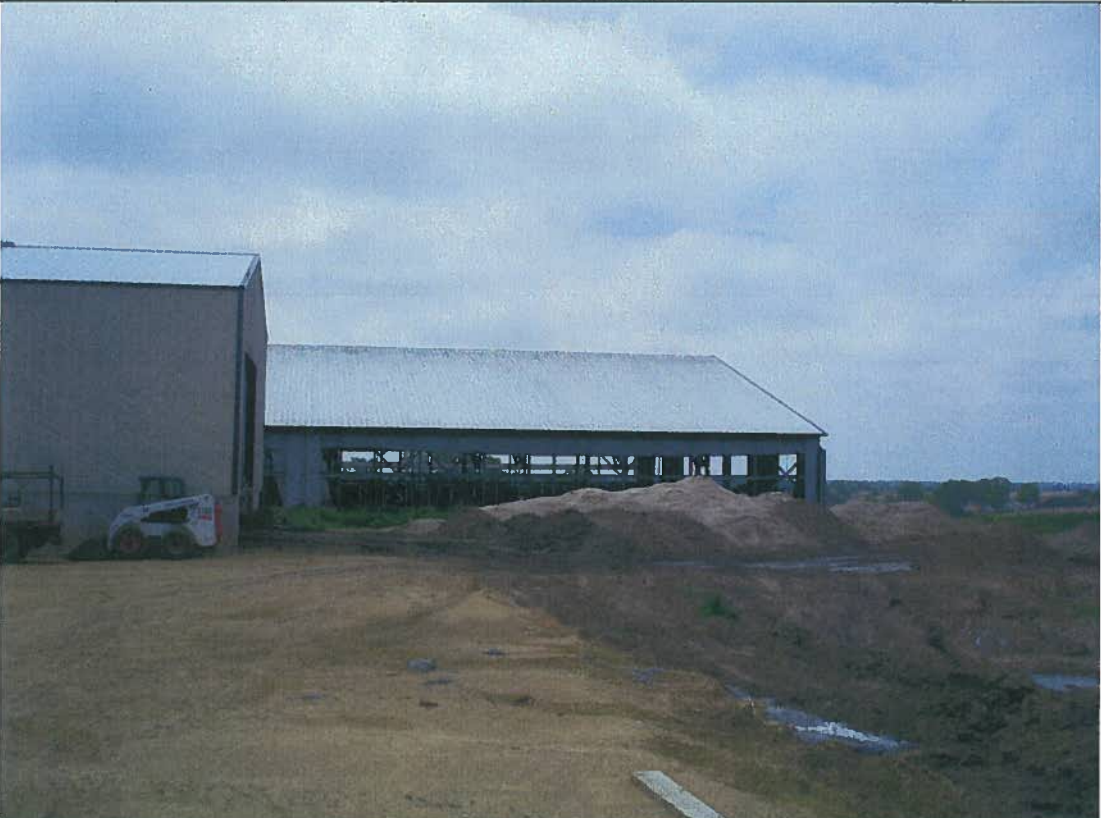
<b>County:</b> Stephenson	
<b>Comments:</b> View of sand separator building with recycled sand at right of photo. View is southwest.	
<b>Photo#:</b> 10	
<b>Photo Title:</b> 052411_ScheidairyFarms_KWB(24)

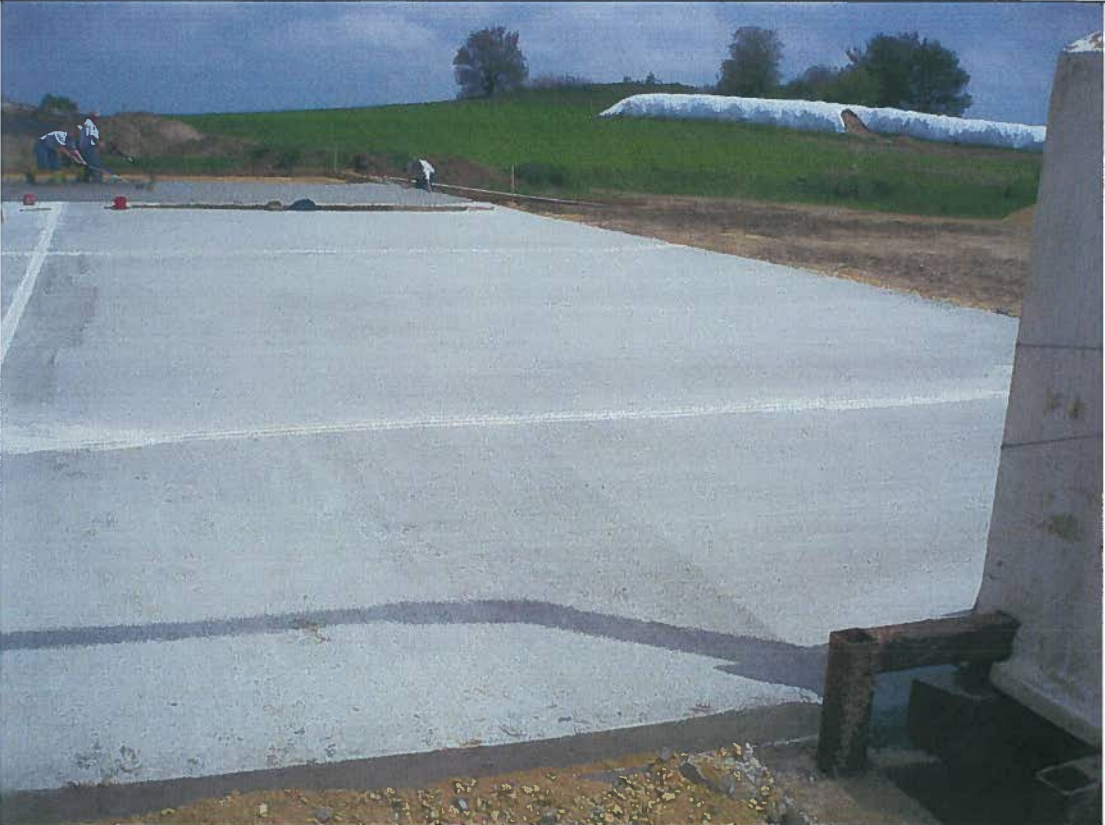
<b>County:</b> Stephenson	
<b>Comments:</b> View of recycled sand storage pad under construction. Runoff will enter pit under shed at right of photo. Silage bags are visible in background. View is northeast.	
<b>Photo #:</b> 11	
<b>Photo Title:</b> 052411_ ScheidairyFarms_KWB(22)

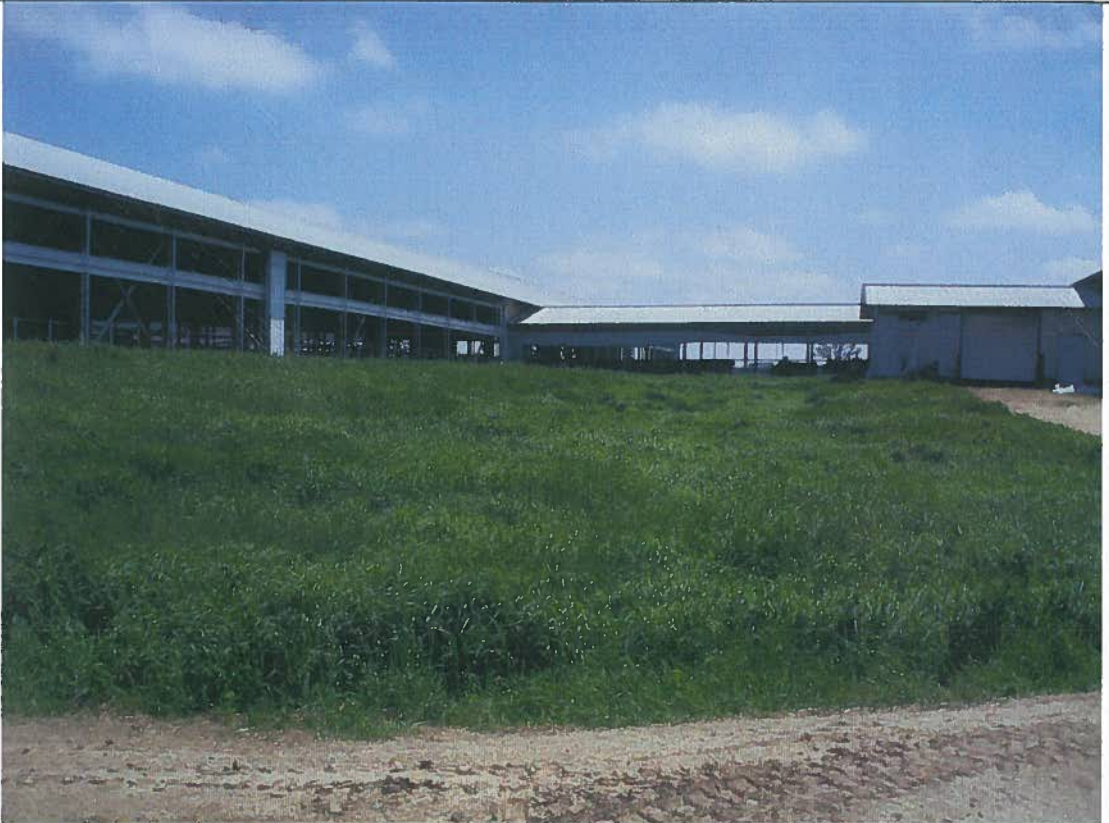
<b>County:</b> Stephenson	
<b>Comments:</b> View of freestall barn and grass swale for storm water runoff. View is southeast.	
<b>Photo #:</b> 13	
<b>Photo Title:</b> 052411_ScheidairyFarms_KWB(33)

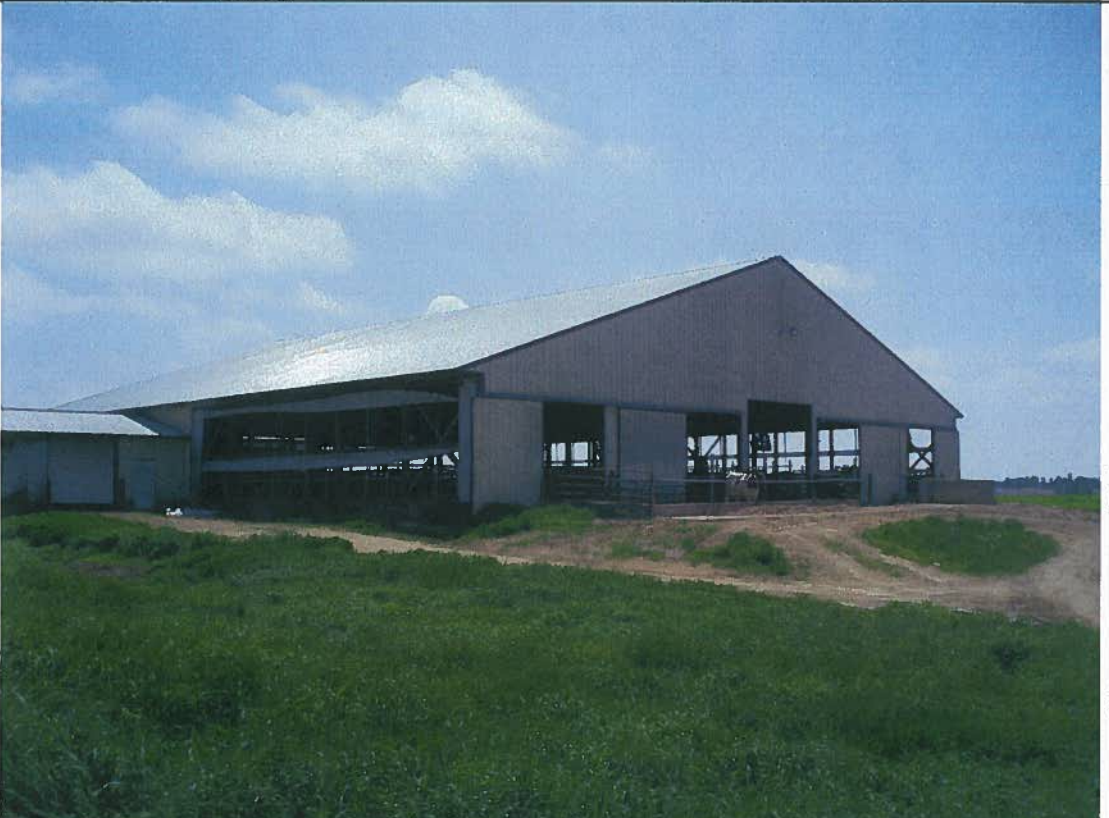
<b>County:</b> Stephenson	
<b>Comments:</b> View of special needs barn. View is southwest.	
<b>Photo#:</b> 14	
<b>Photo Title:</b> 052411_ScheidairyFarms_KWB(32)

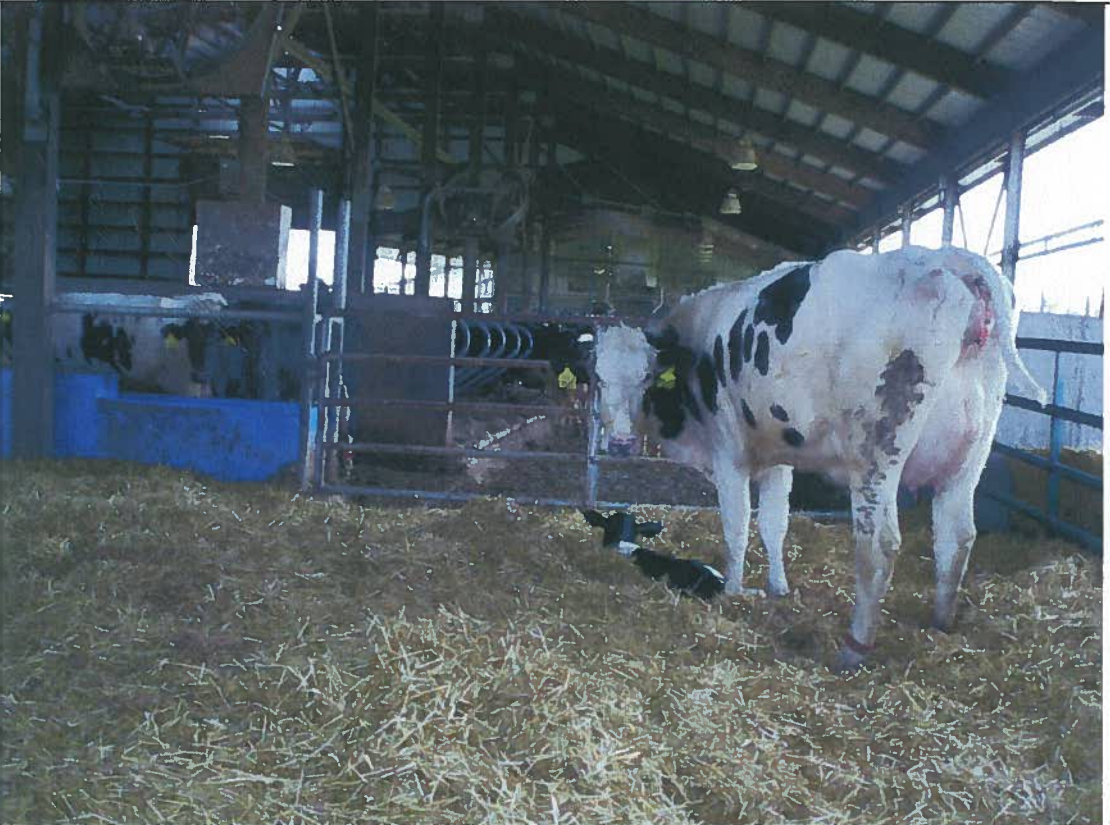
<b>County:</b> Stephenson	
<b>Comments:</b> View of interior of calving area within special needs barn.	
<b>Photo #:</b> 15	
<b>Photo Title:</b> 052411_ ScheidairyFarms_KWB(35)

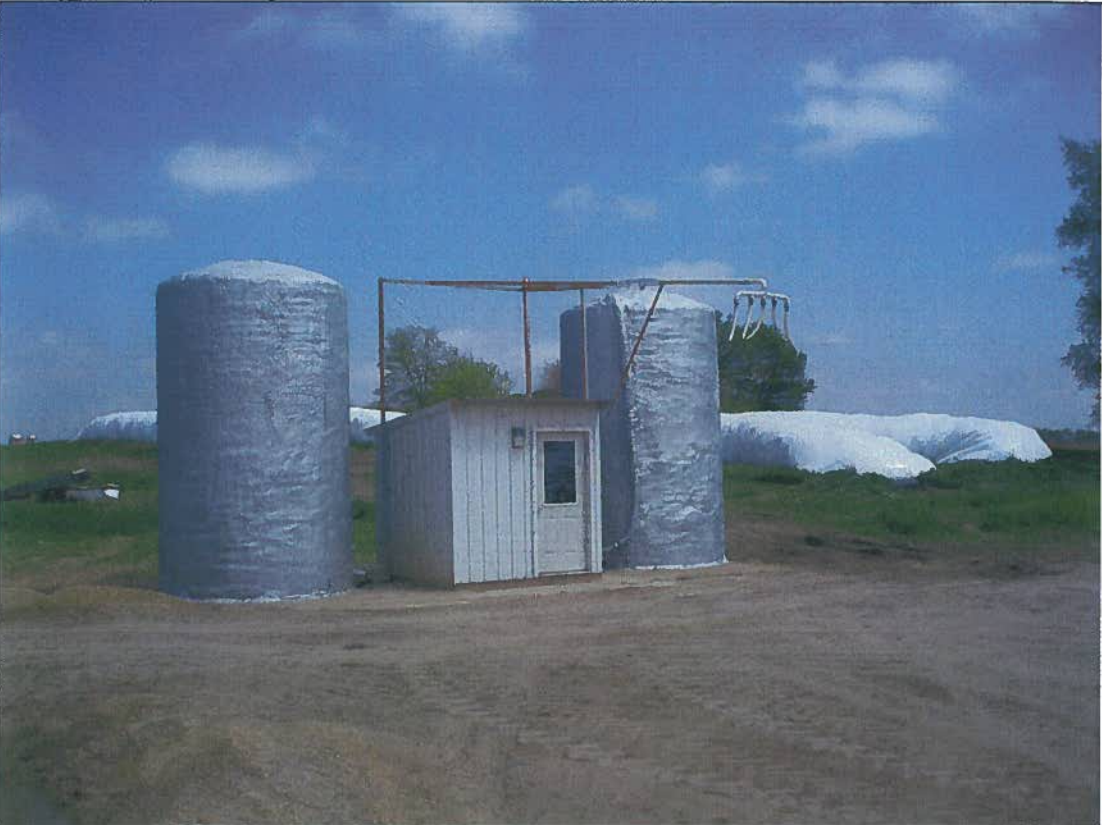
<b>County:</b> Stephenson	
<b>Comments:</b> View of the Scotta (cheese whey) holding tanks and small containment berm. Silage bags are visible in background. Runoff will flow toward point of view and then to grass swale and finally to holding pond. View is northeast.	
<b>Photo #:</b> 19	
<b>Photo Title:</b> 052411_ ScheidairyFarms_KWB(11)

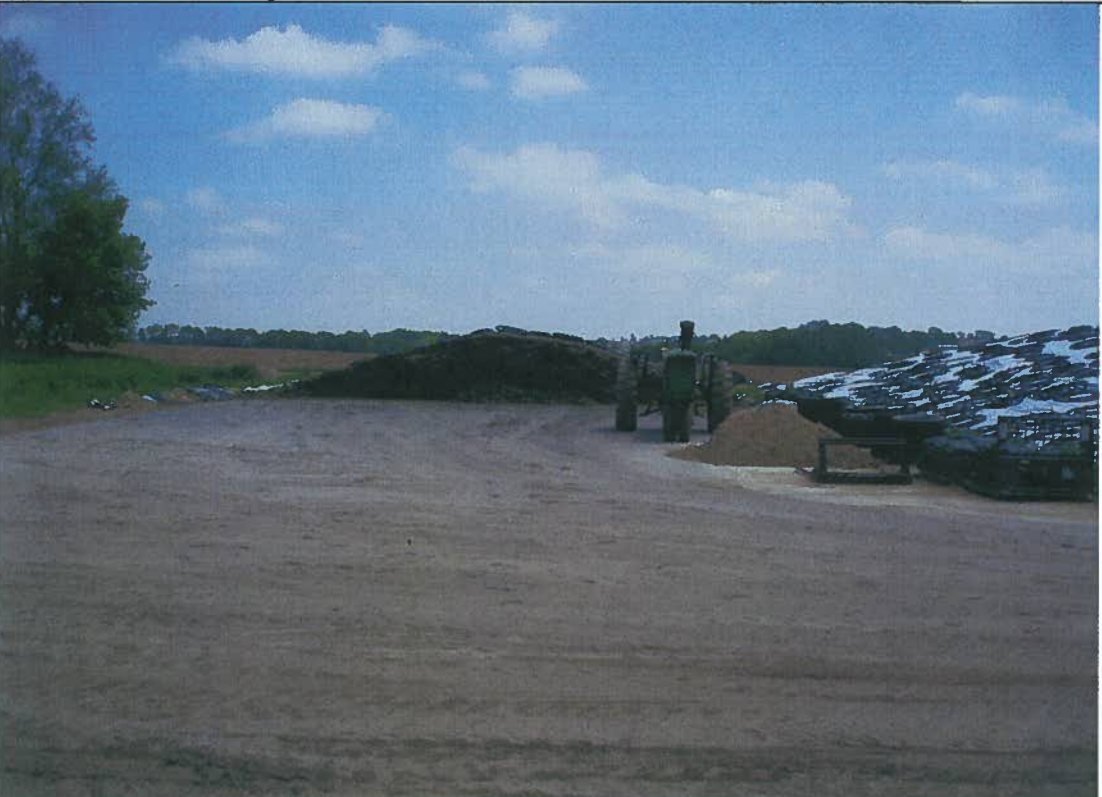
<b>County:</b> Stephenson	
<b>Comments:</b> View of haylage in background with corn silage pad to right. View is east.	
<b>Photo #:</b> 20	
<b>Photo Title:</b> 052411_ ScheidairyFarms_KWB(12)

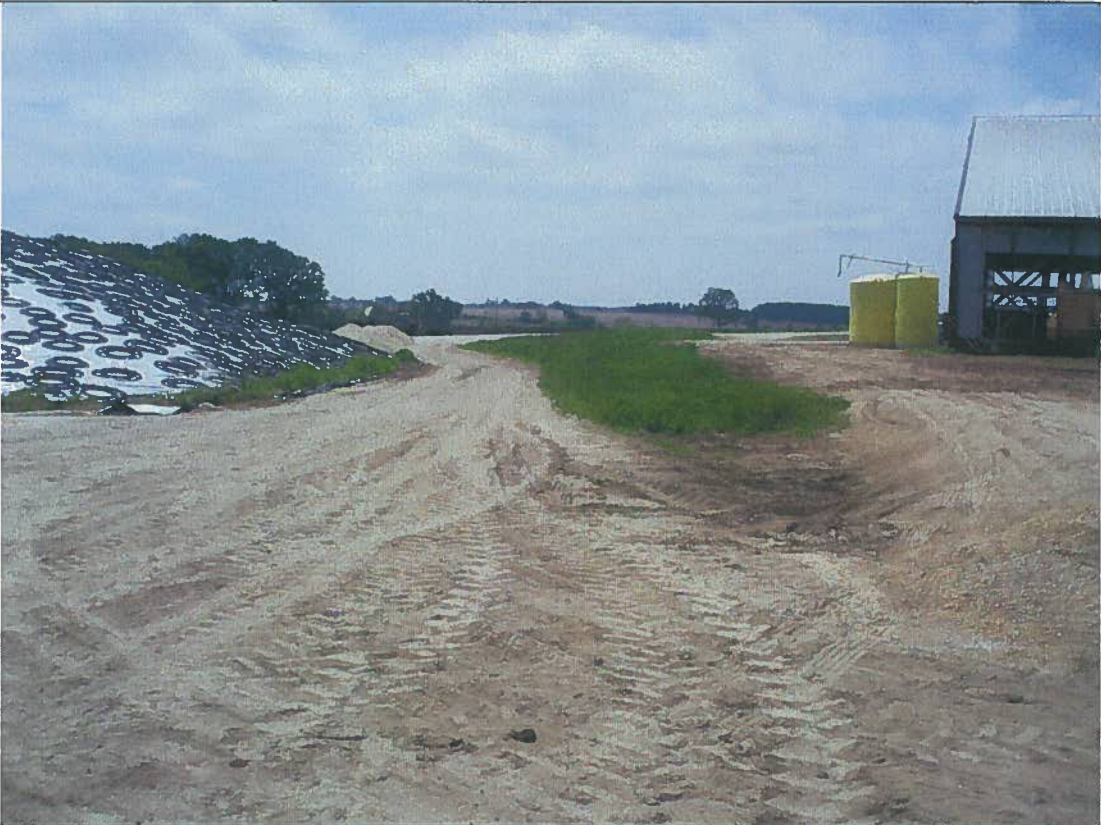
<b>County:</b> Stephenson	
<b>Comments:</b> View of runoff path from haylage and silage bag area. Runoff will flow to west of haylage storage pad in background and then to the holding pond. View is southwest with freestall barn at right.	
<b>Photo #:</b> 21	
<b>Photo Title:</b> 052411_ScheidairyFarms_KWB(15)

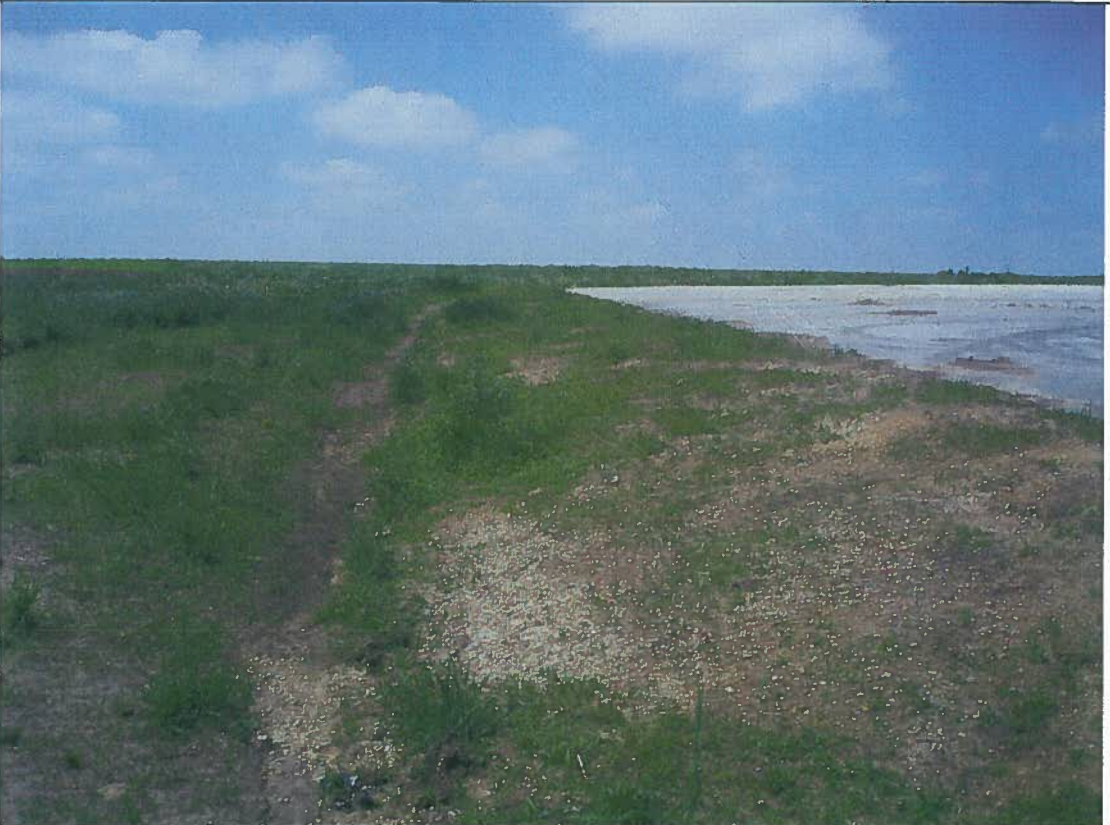
<b>County:</b> Stephenson	
<b>Comments:</b> View of swale downhill from haylage pad that will direct runoff and leachate to the holding pond.	
<b>Photo #:</b> 23	
<b>Photo Title:</b> 052411_ScheidairyFarms_KWB(36)

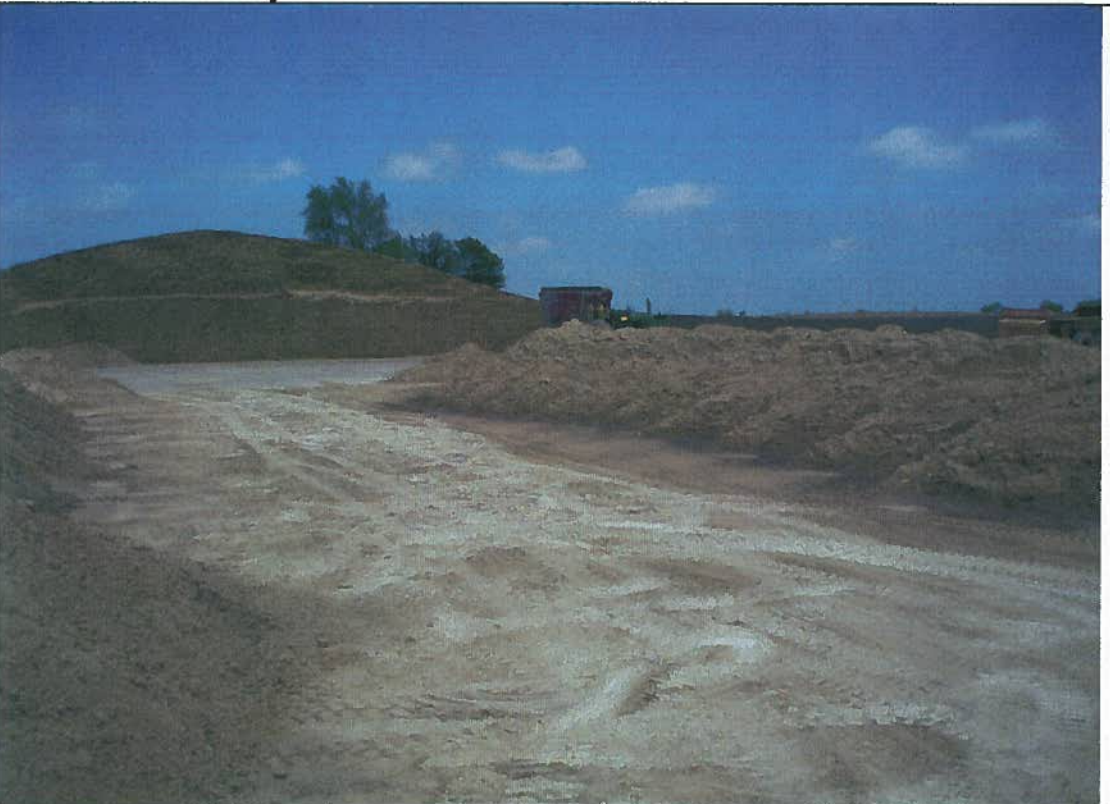
<b>County:</b> Stephenson	
<b>Comments:</b> View of the silage pad with recycled bedding sand in foreground.	
<b>Photo #:</b> 24	
<b>Photo Title:</b> 052411_ScheidairyFarms_KWB(50)

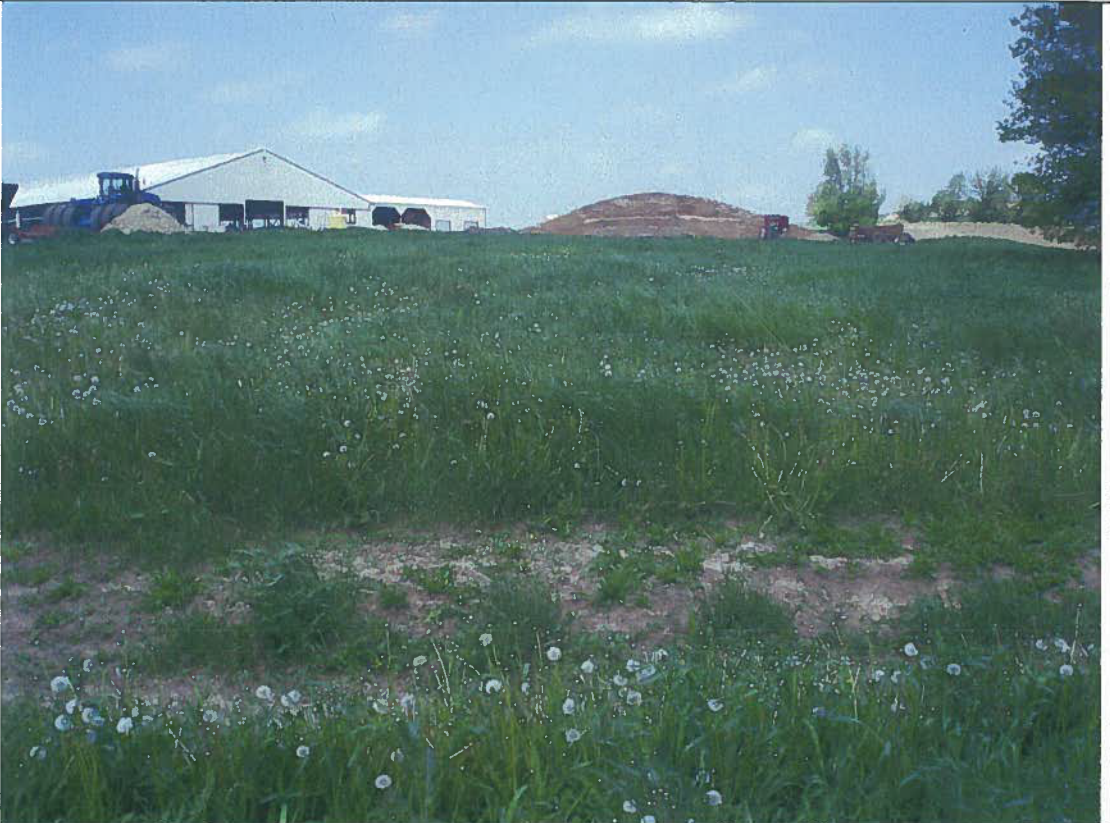
<b>County:</b> Stephenson	
<b>Comments:</b> View of the grass filter downhill from the silage pad. Discharges will enter swale in foreground and flow to the holding pond. View is north with freestall barn at upper left.	
<b>Photo #:</b> 25	
<b>Photo Title:</b> 052411_ScheidairyFarms_KWB(38)

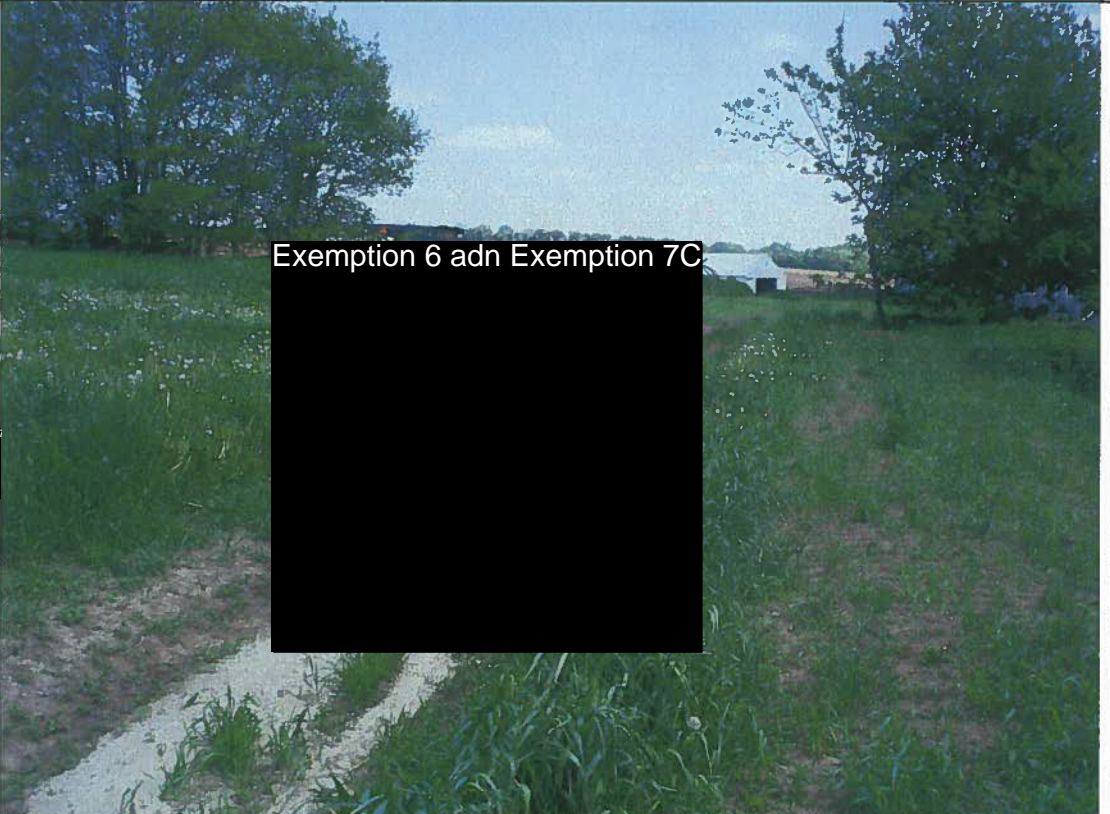
<b>County:</b> Stephenson	
<b>Comments:</b> View of the swale that directs runoff from silage pad and haylage pad to the holding pond. Commodity storage shed is visible in background. <small>Exemption 6 and Exemption 7C</small> <b>Exemption 6 and Exemption 7C</b> View is east.	
<b>Photo#:</b> 26	
<b>Photo Title:</b> 052411_ScheidairyFarms_KWB(37)

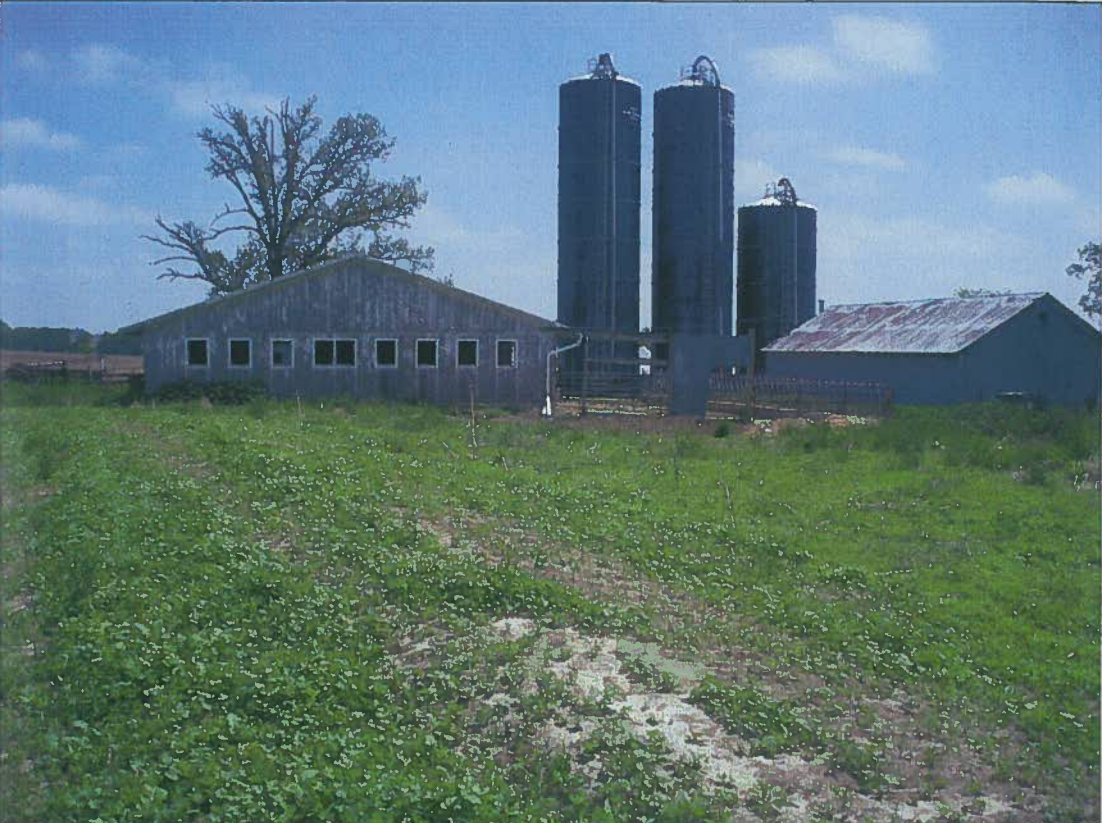
<b>County:</b> Stephenson	
<b>Comments:</b> View of the receiving barn and feedlot. View is southeast.	
<b>Photo #:</b> 27	
<b>Photo Title:</b> 052411_ScheidairyFarms_KWB(39)

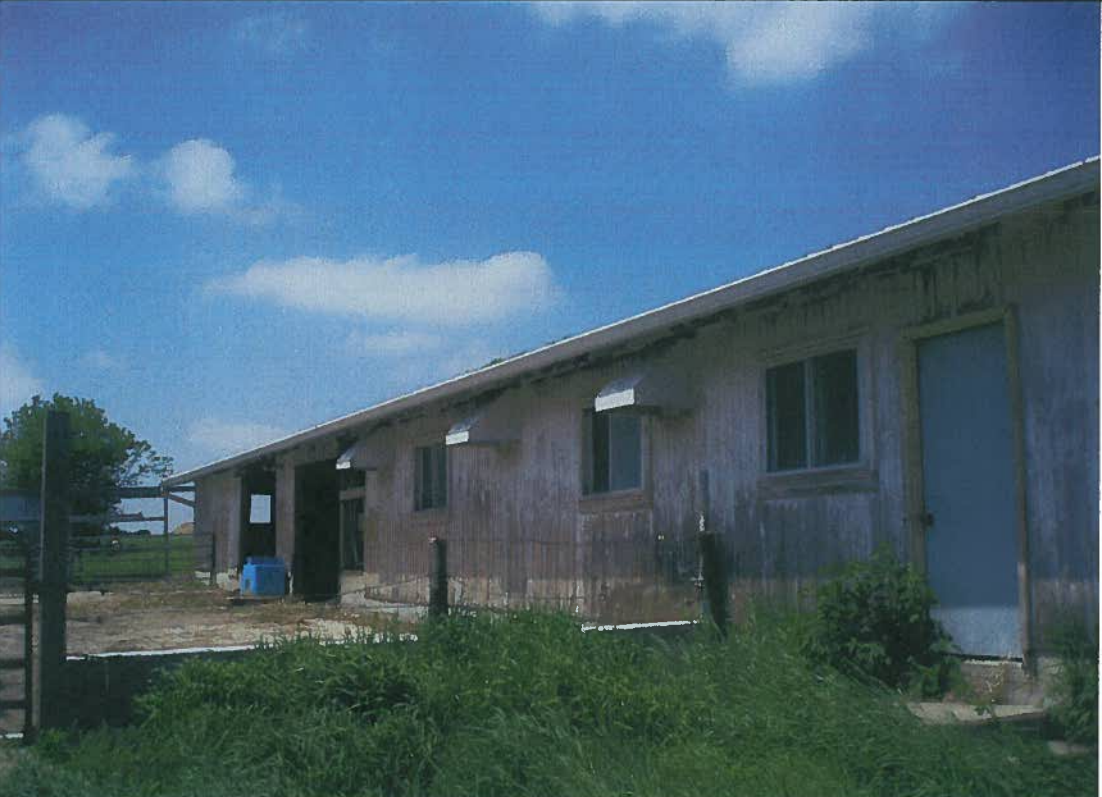
<b>County:</b> Stephenson	
<b>Comments:</b> Another view of the receiving barn. Eave gutters and feedlot containment are visible.	
<b>Photo #:</b> 28	
<b>Photo Title:</b> 052411_ScheidairyFarms_KWB(48)

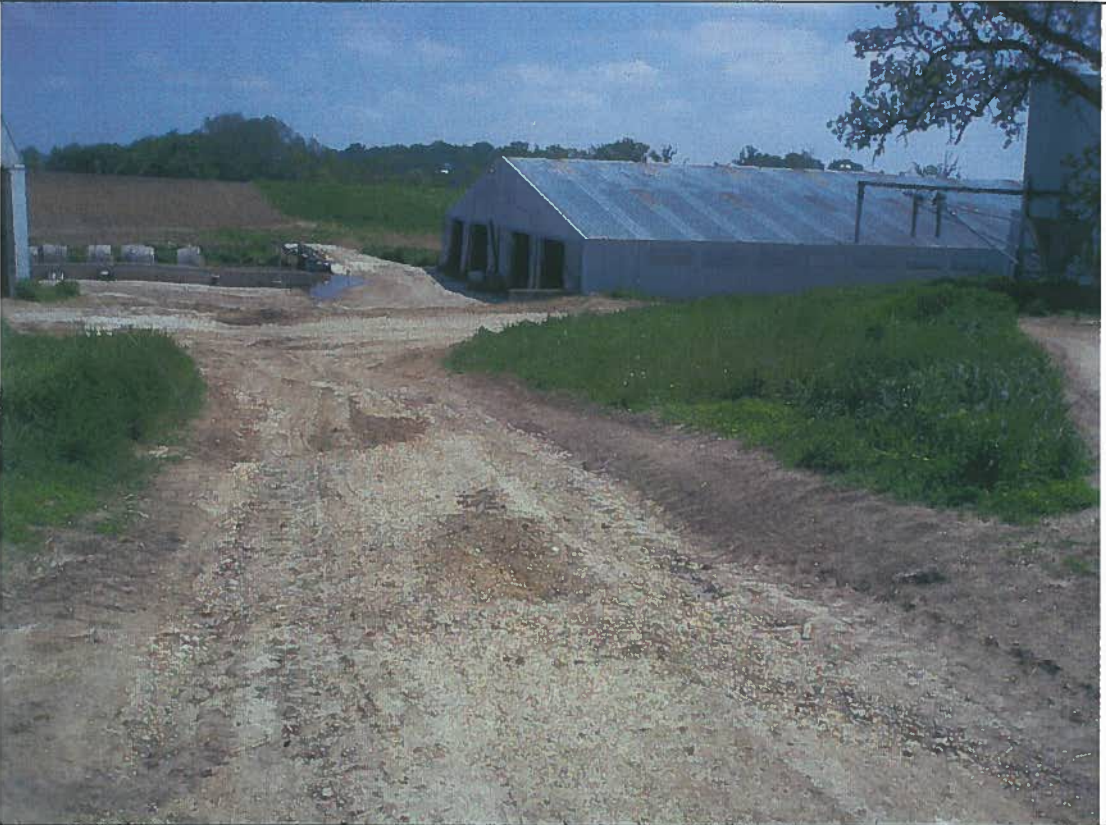
<b>County:</b> Stephenson	
<b>Comments:</b> View of the inactive freestall barn at right. Runoff from silage pads will flow to the holding pond behind the barn. View is east.	
<b>Photo #:</b> 29	
<b>Photo Title:</b> 052411_ScheidairyFarms_KWB(40)

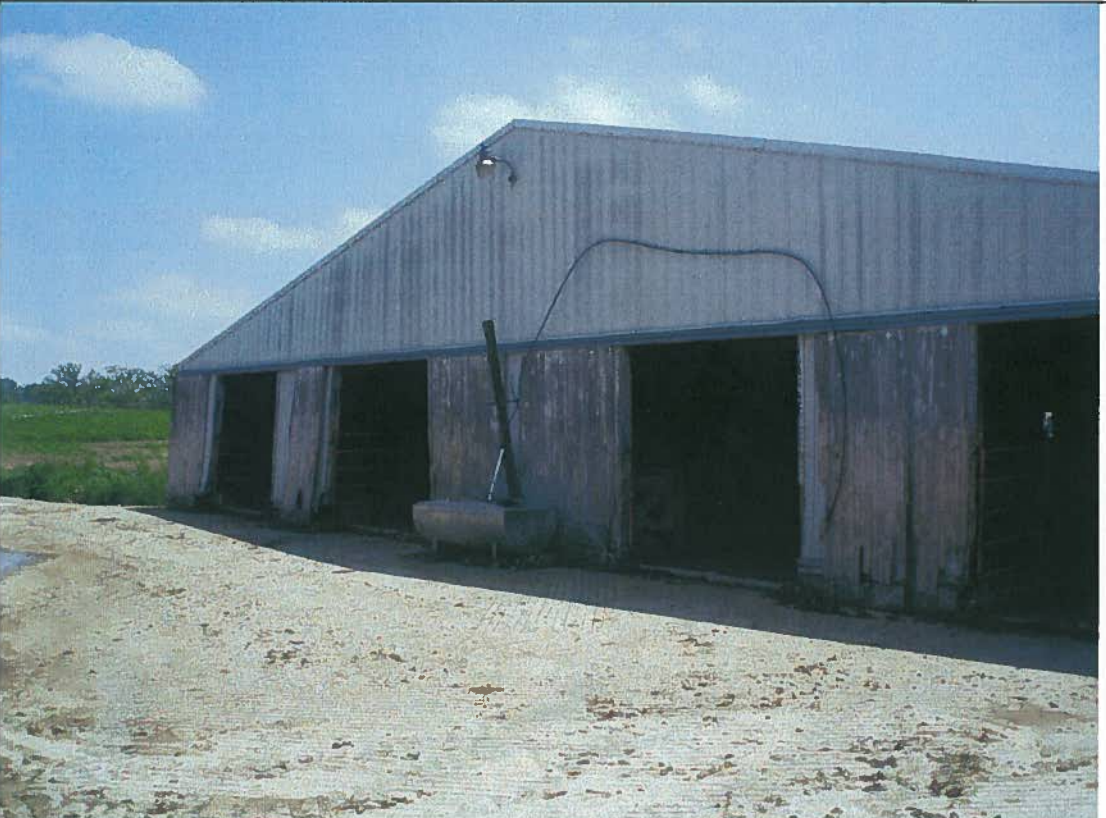
<b>County:</b> Stephenson	
<b>Comments:</b> Another view of the inactive freestall barn. View is southeast.	
<b>Photo#:</b> 30	
<b>Photo Title:</b> 052411_ScheidairyFarms_KWB(44)
